**COMMENTS AND OBSERVATIONS
ON THE DRILLING ACTIVITIES PERFORMED BY
EPA's TAT CONTRACTOR
AND SUBCONTRACTED DRILLER
DURING THE PERIOD OF
JUNE 23 THROUGH JUNE 27, 1992**

**UNITED PARK CITY MINES COMPANY
309 KEARNS BUILDING
SALT LAKE CITY, UTAH 84101**

**PIONEER TECHNICAL SERVICES, INC.
P. O. BOX 3445
BUTTE, MONTANA 59702**

JULY 13, 1992

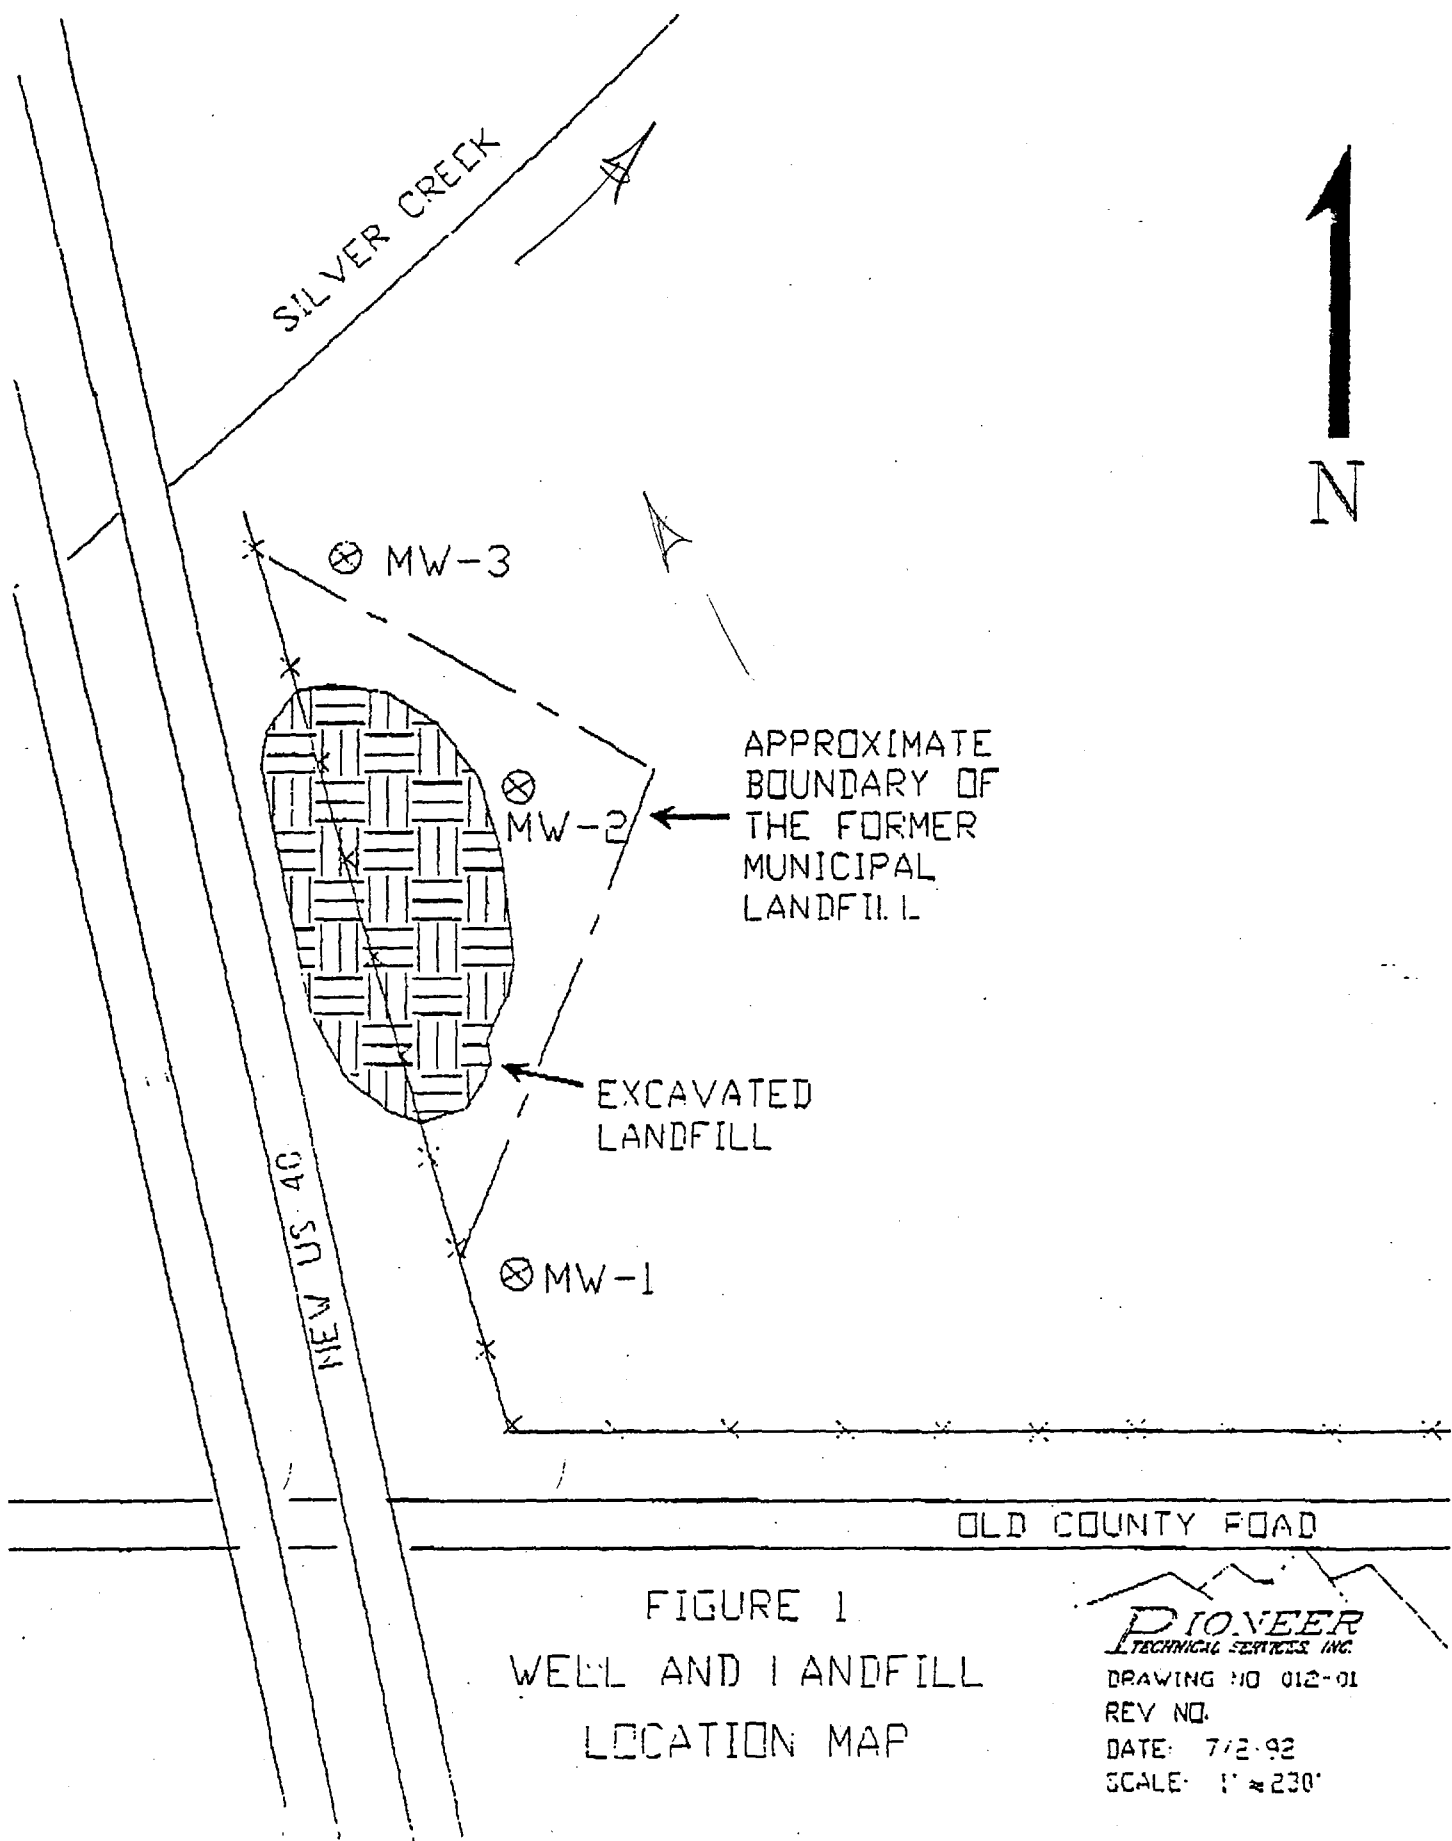
FIGURE 1
WELL AND LANDFILL
LOCATION MAP

A) MONITORING WELL MW-2 WAS INSTALLED WITHIN THE BOUNDARY OF
THE HISTORIC PARK CITY LANDFILL, CONTRARY TO USEPA GUIDANCE.

The most blatant violation of EPA guidance in the drilling of these monitoring wells was the placement of well MW-2 within the boundary of the historic landfill (see Figure 1). USEPA direction is clear - drilling directly through municipal landfills is to be avoided in order to protect underlying groundwater, and for obvious safety considerations; rather, drilling is to be conducted off of the actual landfill and downgradient from it. Prior to drilling, the TAT was advised by the property owner (UPCM) that the location selected for MW-2 was within the former landfill boundary. For whatever reasons, the TAT declined to relocate the well 100 feet to the north, out of the former landfill. After drilling five to ten feet, drill cuttings and split-spoon sample cores showed that the borehole was obviously within the landfill.

At this point, the proper procedure would have been to properly abandon the borehole, move off the landfill, and drill a new borehole in a safer location; however, the TAT persisted with drilling in the landfill. If TAT had adequate training and experience in hydrogeology, they would have anticipated the potential for problems arising from drilling through a landfill, and chosen to drill elsewhere. TAT's lack of experience and refusal to follow USEPA policy, resulted in one of the most serious monitoring well installation calamities possible (described below).

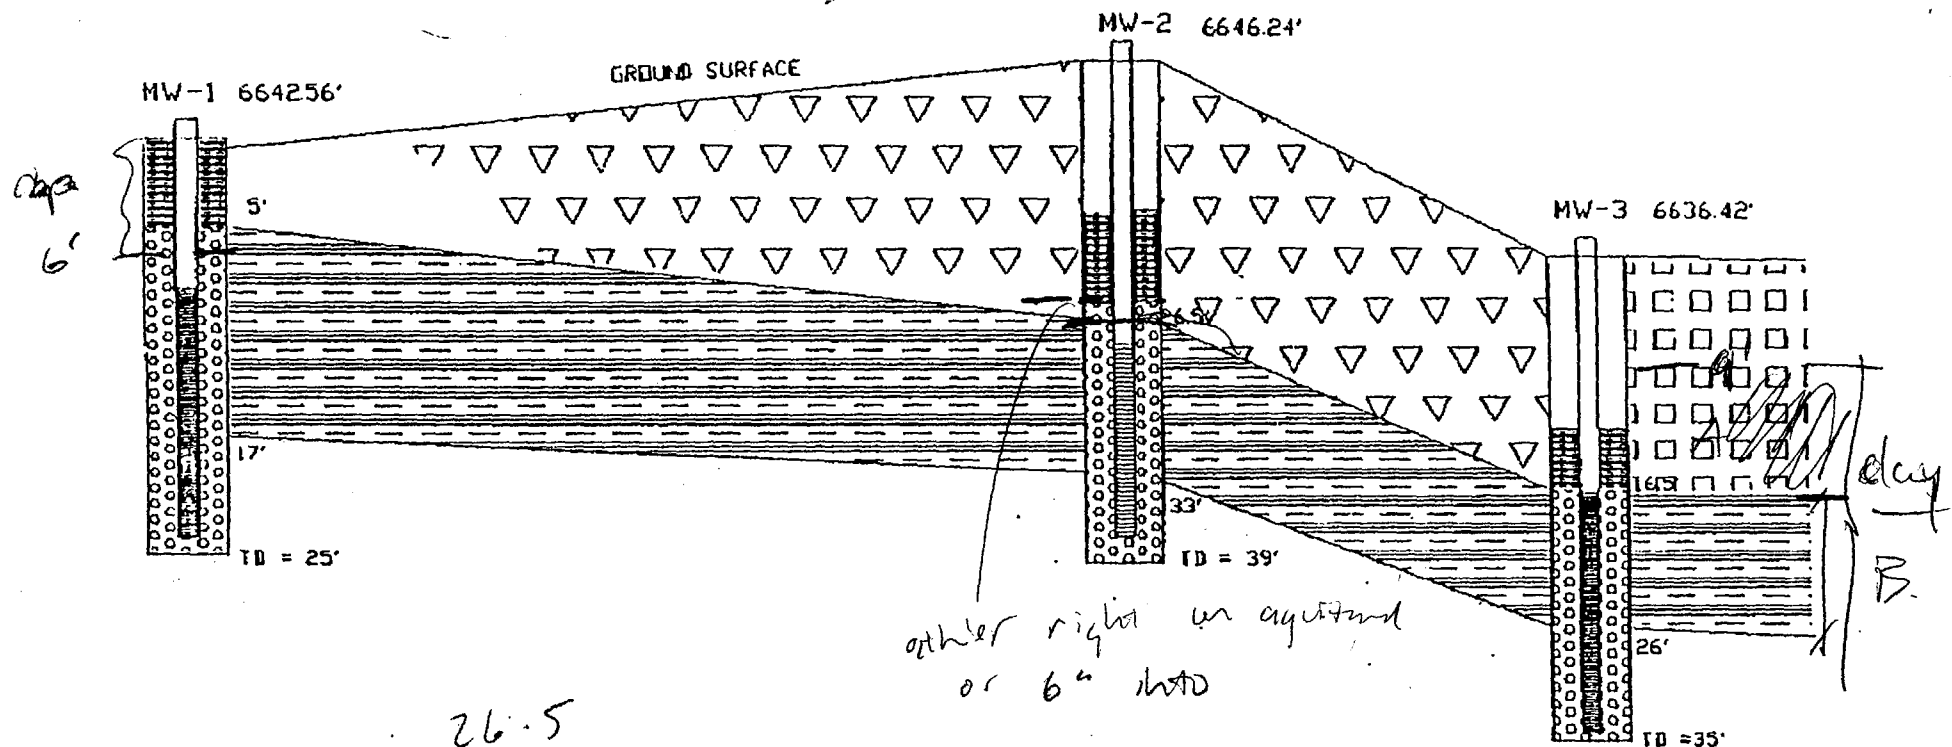
FIGURE 2
GEOLOGIC CROSS SECTION
AND LANDFILL MONITORING WELLS

This is the most egregious violation of sound hydrogeologic practice and may have violated State of Utah regulations for monitoring wells, water wells, or groundwater protection. The drilling of all three monitoring wells showed that the underlying groundwater was a confined or semi-confined aquifer system. In each borehole, the saturated zones were found beneath a thick, apparently continuous aquitard that isolated the landfill materials from underlying groundwater system (see cross-section, Figure 2). In each of the three monitoring wells, the static water level rose to an elevation significantly higher than the level at which water was first encountered.

Borehole MW-1 (upgradient) first encountered this aquitard at 5 feet below ground surface (bgs) and the first groundwater at 16 to 18 feet below the surface (the base of the aquitard). The

borehole was deepened to 25 ft bgs and the well was completed; however, rather than installing 10 feet of screen to 15 ft bgs (near the first water), TAT put in 15 feet of screen, possibly interconnecting several discrete saturated zones. The following day, the water level had risen to only 8 feet bgs, clearly indicating that the underlying groundwater was under pressure.

After ill-advisedly locating well MW-2 within the former landfill (discussed above), drilling commenced. For whatever reason, the TAT did not closely monitor the drill cuttings from the borehole; however, UPCM's hydrogeologist was because of the geology observed at MW-1 and concern about breaching the aquitard underlying the landfill. At 25 ft bgs, a two-foot split spoon core revealed six inches of the aquitard (a reddish-brown clay) in the bottom of the core barrel, clearly showing the top of the aquitard to be at 26.5 ft bgs. The TAT erroneously recorded the top of this unit at 25 ft bgs. Drilling continued (slowly) and water was encountered between 34 and 35 ft bgs. The drilling was halted at 39 ft bgs and well completion activities began.

At this point, serious errors in judgment and perhaps criminal negligence, caused the completion of well MW-2 to be entirely inappropriate, if not illegal. First, 10 feet of screen were placed in the well, bringing the screened section up to 27.5 ft bgs, very close to the top of the aquitard unit. Then, the filter pack was brought up to 26 ft bgs, above the aquitard. The bentonite seal placed on top of the sand was intended to plug the aquitard; however, due to careless geologic logging, it completely missed the aquitard and provides no such seal. The formerly continuous barrier between the landfill materials and groundwater has been breached by the drilling and not repaired during well construction. Water level measurements on subsequent days show clearly that the underlying water is under pressure and has risen up the borehole to exactly 26.5 ft bgs, the top of the aquitard. The underlying groundwater is now flowing up the well under pressure, out through the filter pack along the top of the clay aquitard and into the base of the formerly dry landfill. When this water discharges from the base of the landfill, either as springs or to Silver Creek, it will be contaminated by whatever is in the landfill.

Prior to the installation of well MW-2, the landfill was isolated from the groundwater system. EPA and their TAT contractor have breached this natural compacted clay barrier and are thus solely responsible for the ensuing potential groundwater and surface water contamination.

- secondly, careful geologic logging would have shown the aquitard unit to be between 26.5 and 33 feet bgs, and hence, no need to screen above 33 ft bgs; and,
- finally, the placement of screen and sand up to the base of the aquitard (33-38 ft bgs) and bentonite within the aquitard (26-33 ft bgs) could have maintained the integrity of the natural barrier between the landfill materials and the underlying groundwater system.

The third well, MW-3, was moved further north at the urging of UPCM. During drilling, construction debris was encountered, but no municipal landfill wastes. This well encountered the same hydrogeology and was similarly misconstructured; however, the results are not as critical. The same aquitard (reddish-brown clay) was encountered in MW-3 at 16.5 ft through 26 ft bgs and water was again encountered beneath it. Instead of completing the well with the screened section at 26 to 34 ft bgs, TAT decided to place 15 feet of screen in this well, 5 feet into the aquitard. Filter pack was again placed in the borehole up to the top of the aquitard (16.5 ft bgs), and the bentonite seal above that, again missing the aquitard and not sealing the borehole. The result of this is again, the upward migration of formerly confined groundwater into the construction debris and eventually out of the filled area to surface water.

In any event, the serious nature of the well construction disaster described above is at least unprofessional and at worst illegal. I recommend that all of these wells be properly abandoned as soon as possible. It is especially critical that MW-2 be plugged so that it does not continue to flood the landfill.
